INVESTIGATION REPORT

CATASTROPHIC VESSEL FAILURE

D. D. WILLIAMSON & CO., INC.

REPORT No. 2003-11-I-KY

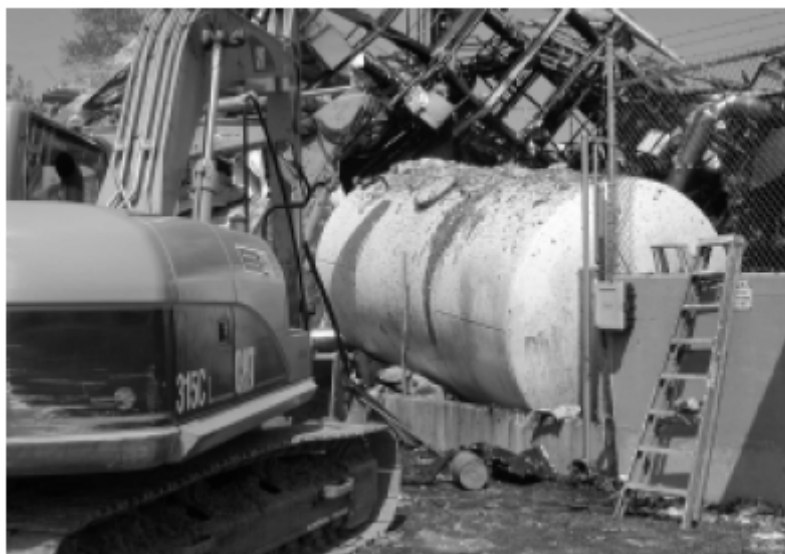
Figure 3. Aqua ammonia storage tank prior to removal from diked area.

The aqua ammonia storage tank was knocked off its foundation and piping was ripped loose, which resulted in the 26,000-pound aqua ammonia leak. An ammonia vapor cloud traveled southwest from the storage tank, toward neighboring homes.

The shell . . . was propelled off its foundation and struck the 12,000-gallon aqua ammonia storage tank . . . which resulted in the 26,000-pound aqua ammonia leak.

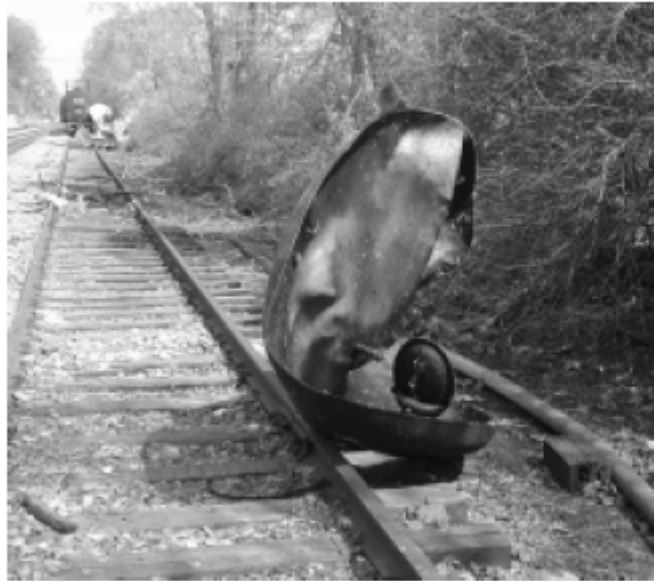
Figure 5. Feed tank #2, top head.

The top head separated at the weld seam and flew approximately 100 yards to the west, landing on the CSX rail line on the north side of the facility (Figure 5).

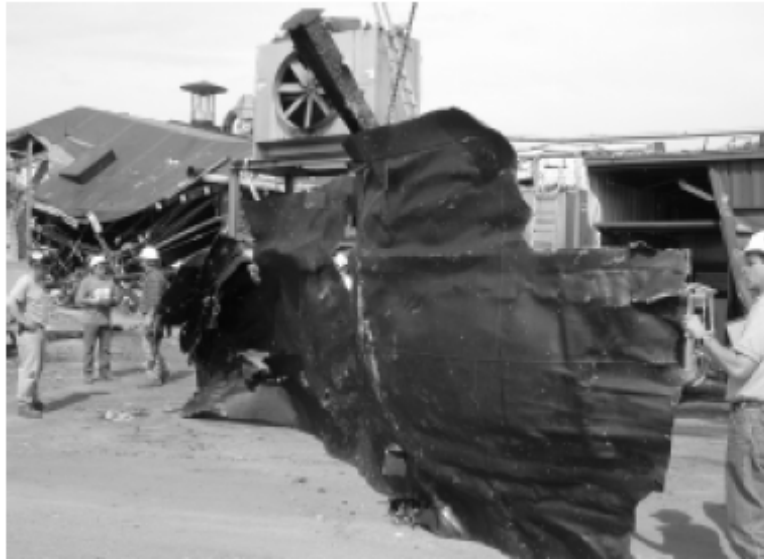
Figure 6. Feed tank #2 shell, after recovery.

- The shell split open in a roughly vertical line. It appears that it was propelled off its foundation and struck the aqua ammonia storage tank, located 15 feet to the west, and then ricocheted 20 feet to the northeast, hitting the bottom of the spray dryer structure and toppling it (Figure 6).

- The bottom head was found directly beneath the tank shell, under the spray dryer structure.

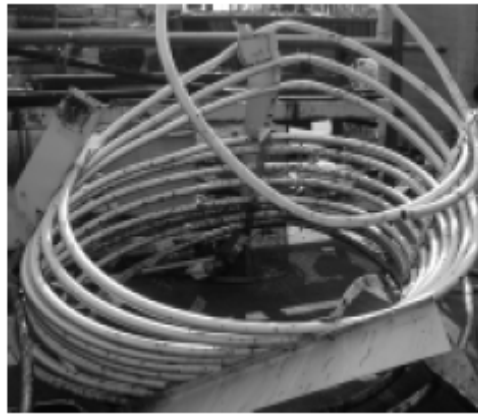
Figure 7. Steam coil ejected from feed tank #2 (photographed in relocated position).

The internal steam coil from tank #2 (Figure 7) was found approximately 30 feet to the south of the tank's original location.

As the feed tank came apart, the coil was ejected and broke apart transversely. The coil retained its round configuration, indicating that the tank did not fail because of an internal deflagration or detonation, which would be expected to deform the coils—but because of pressure exerted somewhat evenly around the circumference of the vessel. CSB tested the coil to determine if a steam leak could have been a causal factor in the incident but was unable to determine whether the coil broke prior to, or as a result of, the explosion. No leaks were found in the intact portions of the coil.

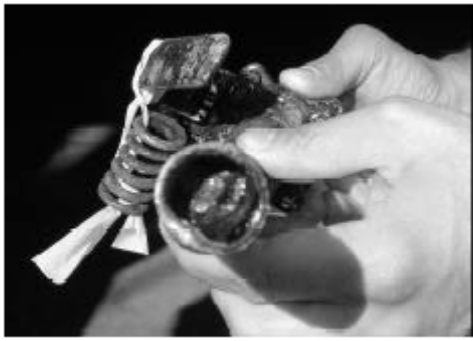
The 1-inch vent valve and a portion of the vent pipe were recovered in a parking lot, approximately 250 feet west of the tank's original location. The valve and pipe were plugged with a hard, sticky black material—typical of overcooked caramel color liquid (Figures 8 and 9). As observed by CSB, the valve appeared to be approximately one-quarter open; however, due to the effects of the explosion, CSB was unable to ascertain the valve position prior to the event.

The valve and pipe were plugged with a hard, sticky black material—typical of overcooked caramel color liquid.

Figure 8 Plugged 1 -inch vent pipe.
pluggage.

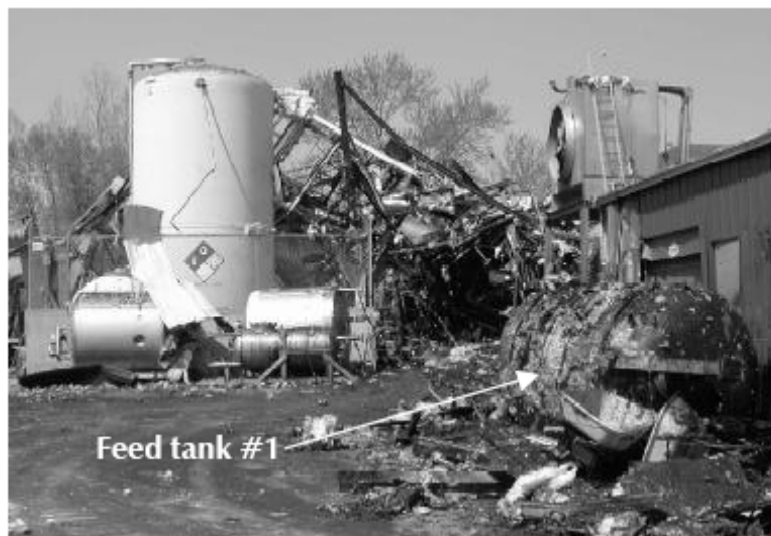
Figure 10. Feed tank #1

Feed tank #1 was propelled to the south and landed on its side, approximately 150 feet from its original location (Figure 10).

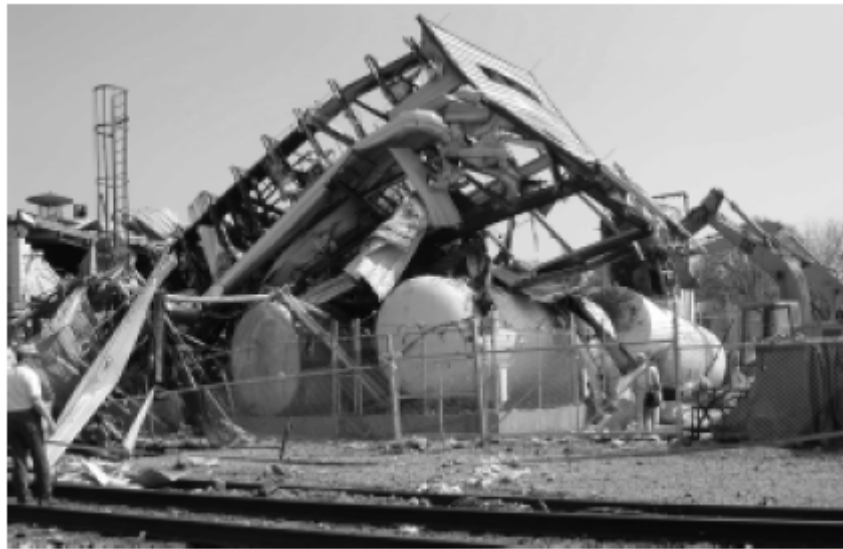
Figure 11. Collapsed spray dryer structure.

- The spray dryer area at the west end of the DDW site was totally destroyed (Figure 11).
- A concrete block wall to the east of the spray dryer area collapsed.
- A 6-inch gas line ruptured; however, automatic valves prevented release of the natural gas.
