**KOREA OCCUPATIONAL SAFETY & HEALTH AGENCY**

## **INVESTIGATION REPORT**

### **Explosion in Compressor Operating Panel**

**Ulsan, Korea  
September , 2004**

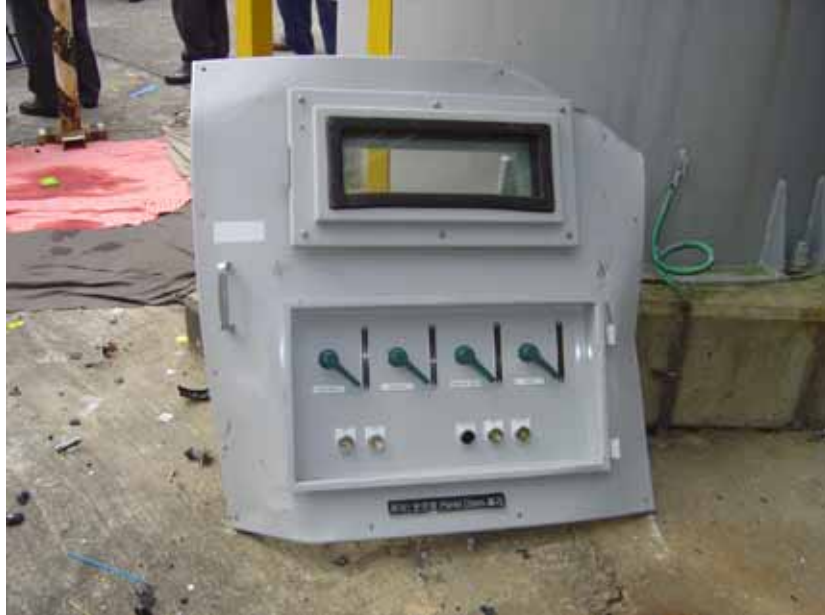
**Figure 1: Damaged compressor operating panel cover after explosion(weight about 60kg)**

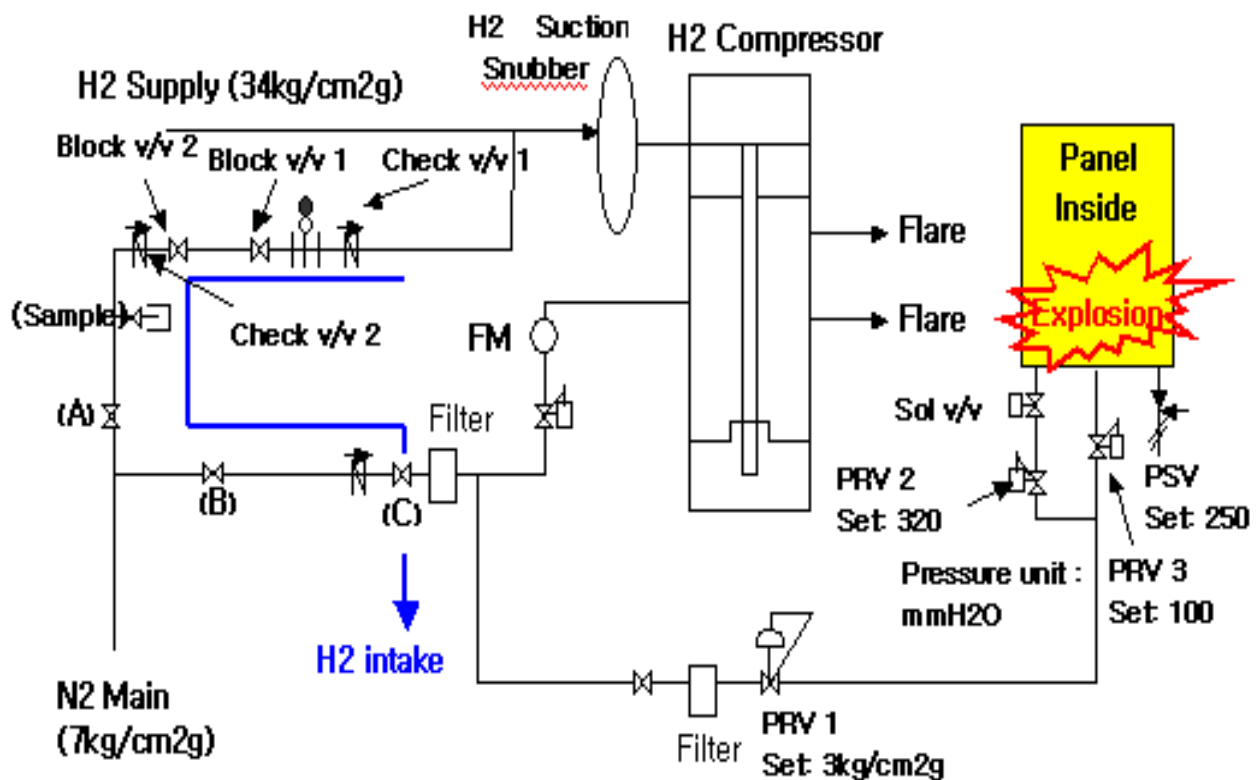
Fig. 2 : Schematic Drawing of incident

In the morning of September, 2004 a explosion was occurred in a compressor operating panel in a P.P (Polypropylene) Plant, Ulsan, Korea. Two employees were killed on the spot, the panel was damaged itself. The explosion was arisen due to high pressure hydrogen trespass through nitrogen line for compressor panel purge. Nitrogen was supplied to purge compressor suction part during the maintenance period and also to pressurize and hold positive pressure compressor operating panel inside from the same header. And when nitrogen valve was opened to purge compressor suction part to replace the compressor inside valves, nitrogen valve connected to compressor operating panel was closed by mistake. So compressor operating panel inside finally remained in atmosphere and air entered in panel through openings.

After the replacement of compressor inside valves nitrogen purge line was not exactly blocked. Between compressor suction part and N2 header line two check valves and two gate valves and a globe valve and a spectacle blind was installed but two check valves passed, two gate valves(valve 1,2) opened, a globe valve passed, a spectacle blind unused. And high pressure hydrogen trespassed in the compressor operating panel through the nitrogen purge line according to compressor running and the explosion finally occurred in panel by electric sparks.

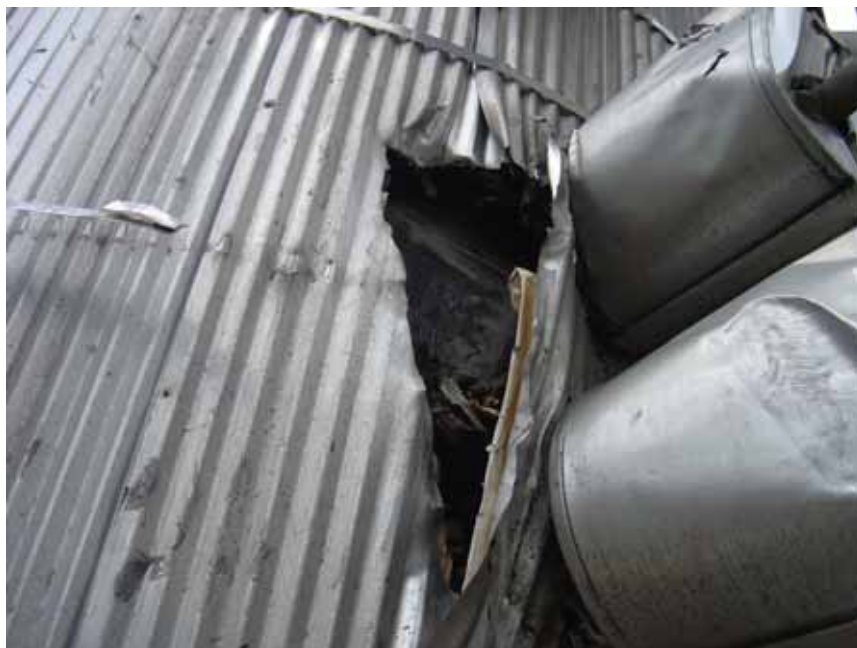
**Fig. 3: Impact mark on the adjacent drum by exploded compressor panel cover**

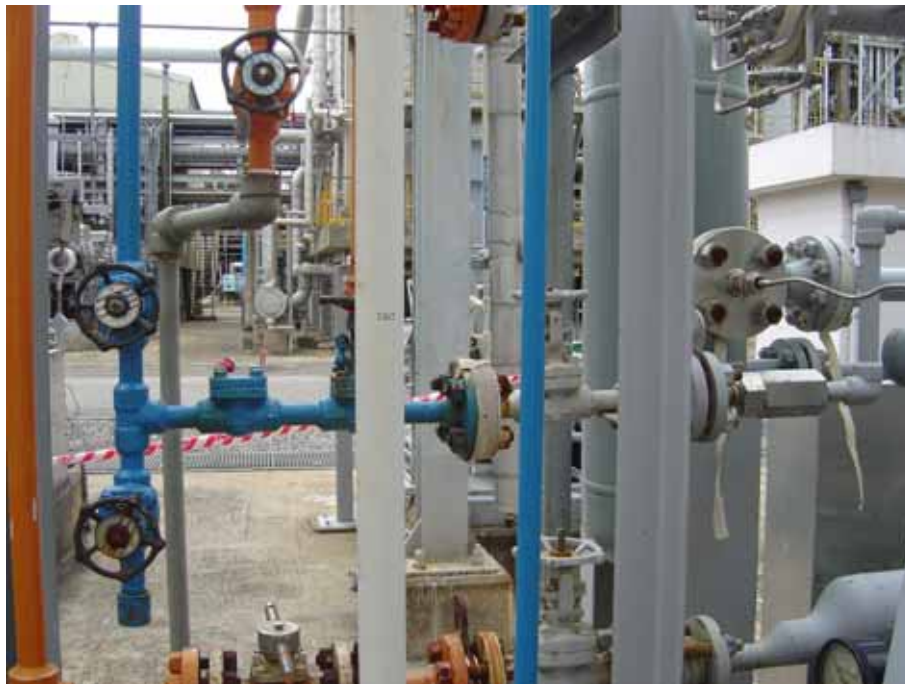
**Fig. 4 : Nitrogen purge line of compressor suction part**

**(Between compressor suction snubber and N2 header line check v/v 1 , blind, gate v/v 1, globe v/v, check v/v 2, gate v/v 2 were installed but check 1, 2 passed, gate v/v 1,2 opened, globe v/v passed, blind unused )**

After the maintenance of compressor suction part N2 purge line should be blinded but a spectacle blind was not used because it was located in back of a check valve that is easy to be passed, and nitrogen for compressor operating panel purge was supplied from the same line that was used for the purge of high pressure hydrogen parts. Generally purge gas of an electric panel to hold positive pressure is instrument air.

And this actually shows the trespass of H<sub>2</sub> from compressor suction snubber. The leak test results of all valves of between N<sub>2</sub> header line and compressor suction snubber showed the same results, and two check valve was passed, blind unused, two gate valve opened, a globe valve passed.

A spectacle blind was located in back of a check valve that is easy to be passed, and purge gas for compressor operating panel purge was not instrument air but nitrogen supplied from the same line that was used for the purge of high pressure hydrogen parts.

Two check valve and a globe valve passed but any inspection was not performed.

A spectacle blind should be located in back of a block valve so that N2 purge line should be blinded after the maintenance of compressor suction part, and purge gas to hold positive pressure in an electric panel is recommended to change instrument air instead of nitrogen gas.
