**KOREA OCCUPATIONAL SAFETY & HEALTH AGENCY**

## **INVESTIGATION REPORT**

### **REBOILER HEATER TUBE FIRE**

**Ulsan, Korea**

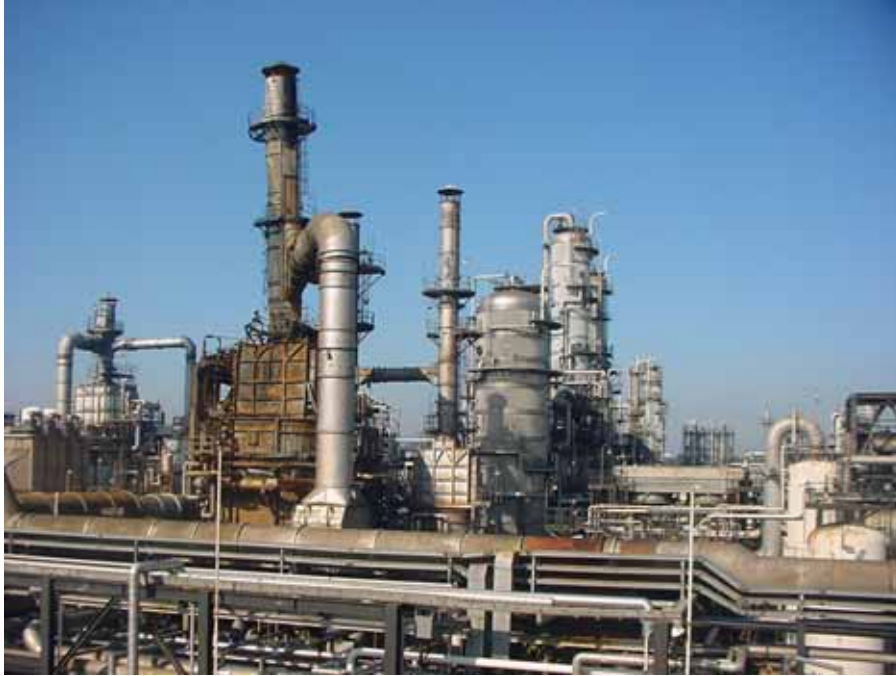
**Figure 1: UC(Unicracking) Unit after fire**

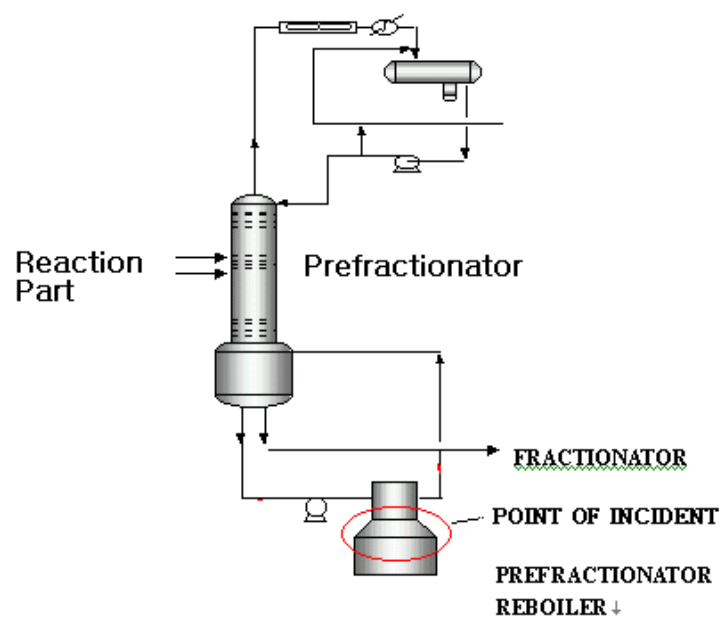
Fig. 4 : Point of Incident of UC Unit

In the midnight of October, 2003 a pre-fractionator reboiler fired in a UC(Unicracking) Unit of HOU (Heavy Oil Upgrading)Plant, Ulsan, Korea. The fire broke out on the eighth row tube on the convection part of the heater. It continued for 2 hours and damaged reboiler itself and facilities. The upper side of the convection tube (pass 'E' ; row 8 in Pre-fractionator reboiler heater) had ruptured that it caused fire,

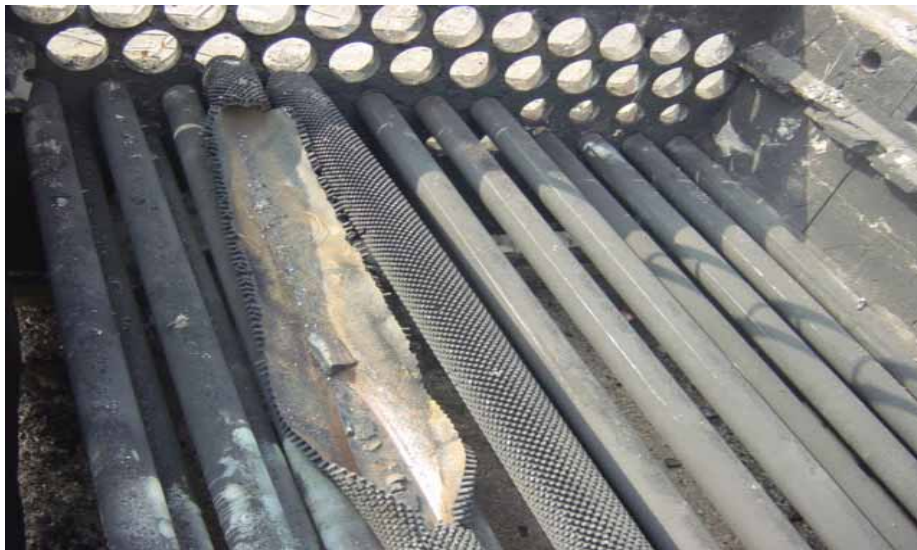
Fig. 5: Ruptured Tube

The general corrosion of whole tube and local corrosion of slug flow inside tube from material vaporization made the thickness of tube to be thin therefore it became of tube rupture.

Reboiler heater tube and subsidiary tube material of construction need to be upgraded. In addition, the scope of material selection and replacement policy shall be rechecked and revised.

Convection tube inspection period & inspection method shall be revised considering operation condition of heater convection section, material and corrosion status, and then the inspection period and method to be decided clearly.

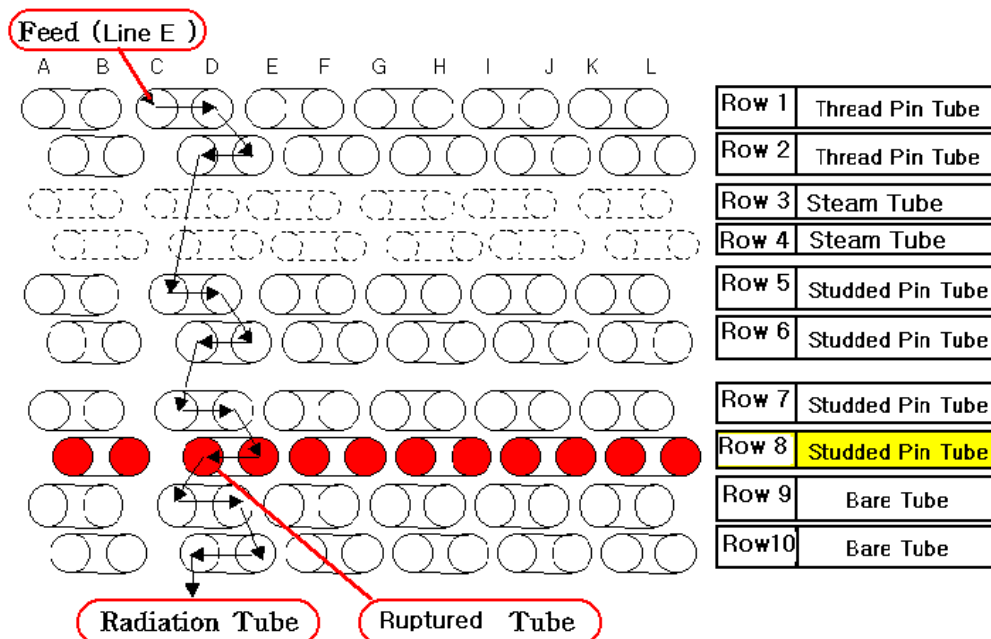
Fig. 6 : Heater Tube Arrangement

- Generally it has a kind of high temperature  $H_2S$ -  $H_2$  Corrosion trend and especially the corrosion of middle row is more serious than that of lower row tube walls in the convection section under high temperature. The rows 7 and 8 showed more serious corrosion.

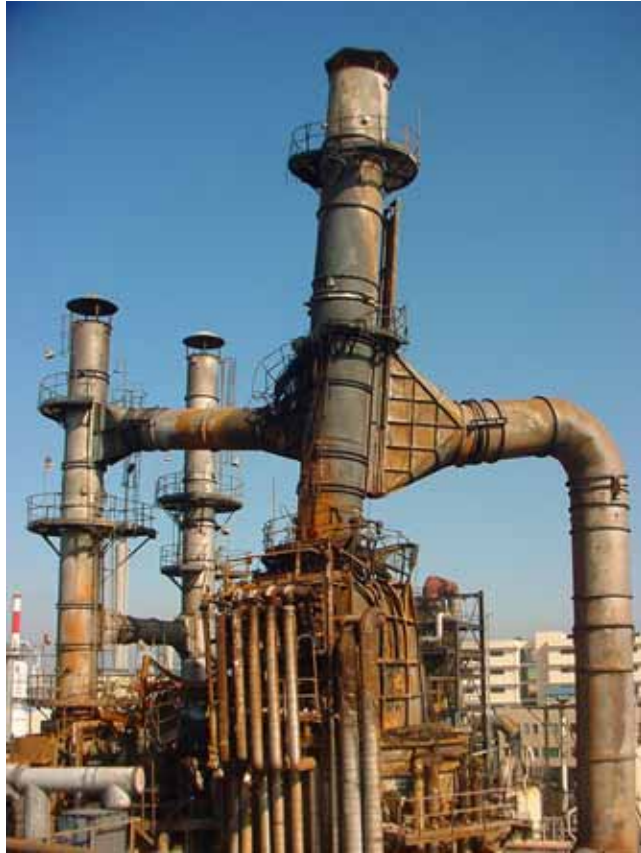
**Fig. 7 : Appearance of the Reboiler Heater after Fire**

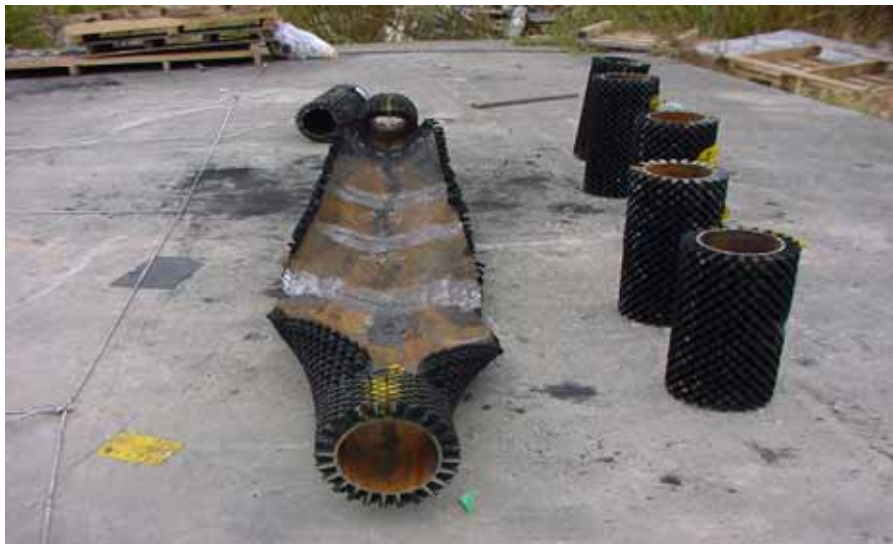
**Fig. 8 : Ruptured Tube Detached from the Heater Convection Box**

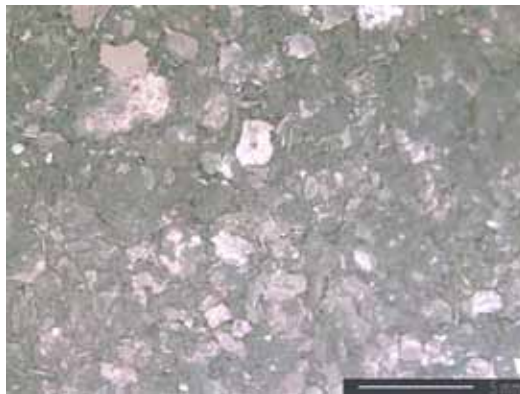
- In the view of external inspection and component analysis, most of contents were  $FeS$  which was corrosion residue of tube metal from typical Sulfur.

Fig. 9 : View of Scale in the Tube Inside -EDX(Energy Dispersive X-Ray)Analysis
