INVESTIGATION REPORT

CATASTROPHIC VESSEL FAILURE

D. D. WILLIAMSON & CO., INC.

REPORT No. 2003-11-I-KY

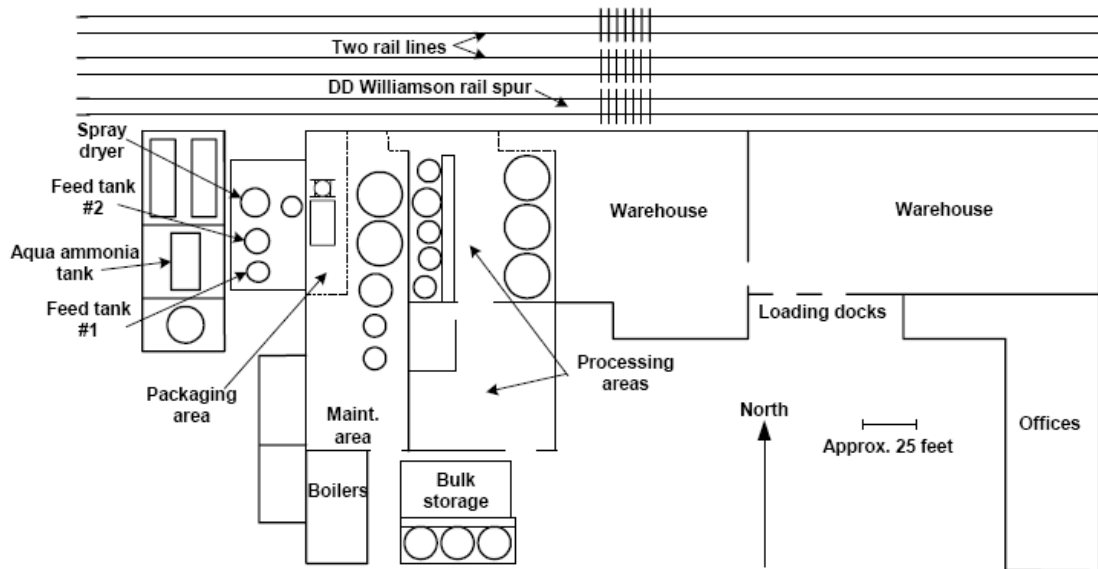
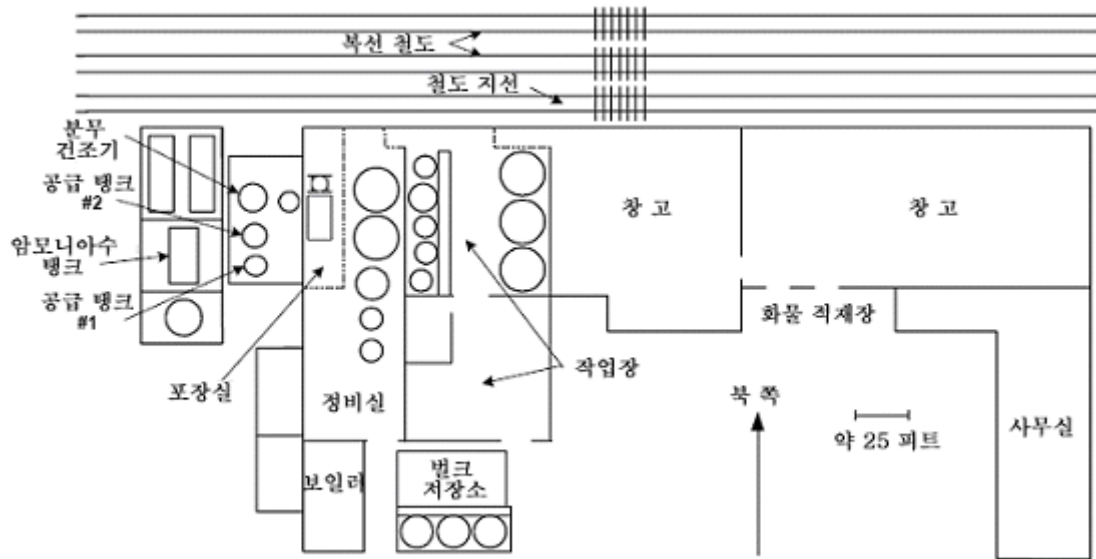
Figure 1. DDW plant layout.

The April 11 incident occurred in the spray dryer area at the west end of the plant (Figure 1). The spray dryer was located 6 feet north of feed tank #2 (Section 1.5), the tank that exploded. Corrugated aluminum walls enclosed the spray dryer area, and a concrete block wall to the east separated it from other processing areas of the facility. The aqua ammonia storage tank was one of four tanks located just outside and to the west of the spray dryer area; of the other three tanks, one was empty, one was a 12,000- gallon horizontal tank of 50 percent caustic soda, and one was a 20,000- gallon vertical tank of ammonium bisulfite.

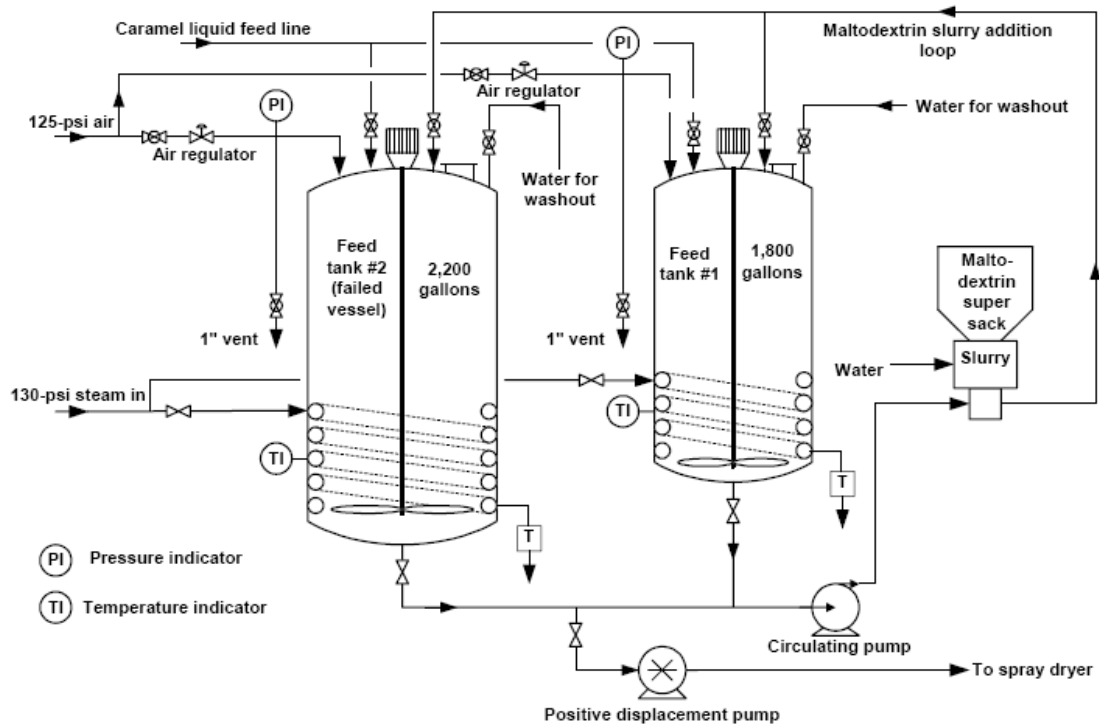
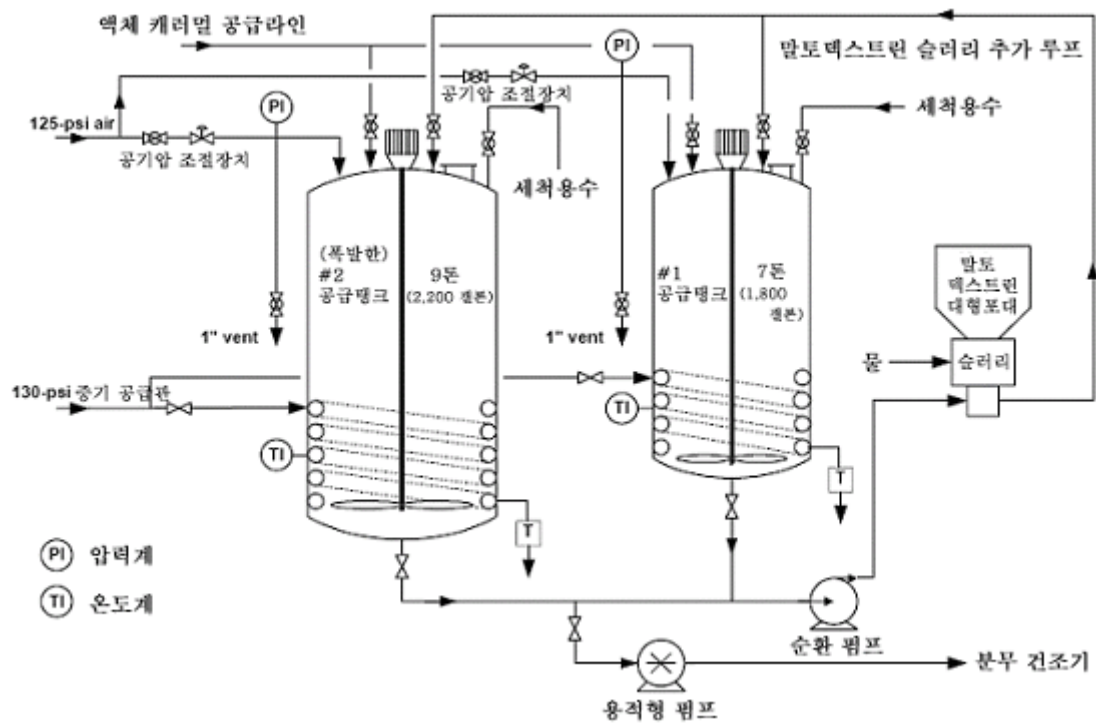
Figure 2. Feed tank flow schematic.

One 1,800-gallon tank (feed tank #1) and one 2,200-gallon tank (feed tank #2) fed the DDW spray dryer (Figure 2). These stainless-steel pressure vessels were equipped with internal stainless-steel coils for heating with steam or cooling with water and with agitators for mixing.

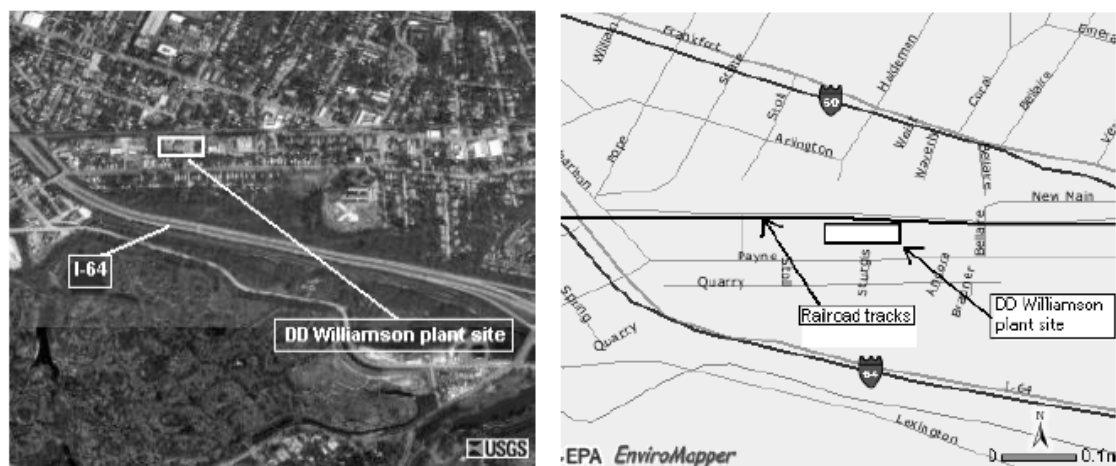
Figure 4. DDW aerial photograph and location map

connections, steam leaks, and the strong smell of natural gas from a broken fuel line. They called the Louisville 9-1-1 center to report the incident and immediately proceeded to isolate and shut down the area. The plant's automatic alarm system had already notified the DDW alarm service, which contacted the Louisville Fire Department. The employees turned off the steam, shut down the plant boilers, and isolated the area before leaving, at which time the Louisville Fire and Police Departments had arrived on scene. Automatic valves on the natural gas system worked as intended, and there was no fire as a result of the explosion. During the incident, the Louisville/Jefferson County EMA and the Metro Louisville Health Department obtained maximum ammonia readings of 50 parts per million (ppm) at the DDW fence line and 35 ppm on Payne Street.⁵ The Fire Department evacuated two blocks of Payne Street closest to the facility. Twenty-six residents were moved into buses at either end of Payne Street, but they did not leave the area. The Fire Department, emergency radio, and news media notified approximately 1,500 residents within 0.5 mile of DDW to shelter-in-place. No injuries were reported in the area of the ammonia release (Figure 4).

Because ammonia concentrations of 70 to 100 ppm were obtained in the immediate vicinity of the leak, the Fire Department hazardous materials unit personnel wore self-contained breathing apparatus and fully encapsulated suits. They made two entries into the blast area to search for the missing employee, to locate the source of the aqua ammonia leak, and to conduct air monitoring. At 7:00 am, a third entry was made with plant employees, who assisted in securing the leak. Residents were allowed to return to their homes at 9:00 am.

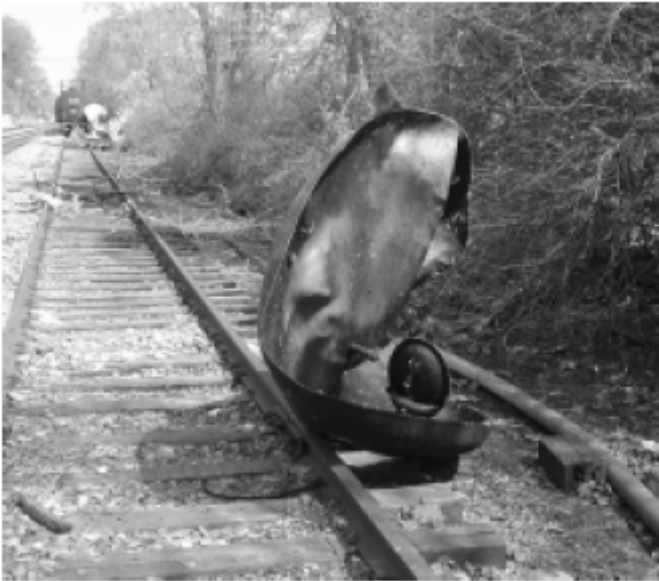
5 #2

The top head of the feed tank separated at the weld seam and was propelled approximately 100 yards to the west, landing on the CSX rail line on the north side of the facility. The shell split open in a roughly vertical line. It appears that it was propelled off its foundation and struck the 12,000-gallon aqua ammonia storage tank, located 15 feet to the west (Figure 3); and then ricocheted approximately 20 feet to the northeast, hitting the bottom of the spray dryer structure and toppling it.

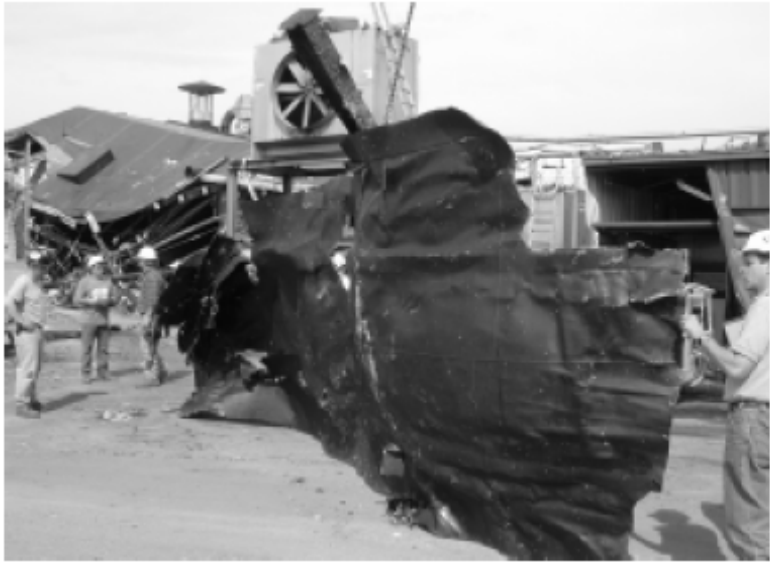
6. #2

- The shell split open in a roughly vertical line. It appears that it was propelled off its foundation and struck the aqua ammonia storage tank, located 15 feet to the west, and then ricocheted 20 feet to the northeast, hitting the bottom of the spray dryer structure and toppling it (Figure 6).

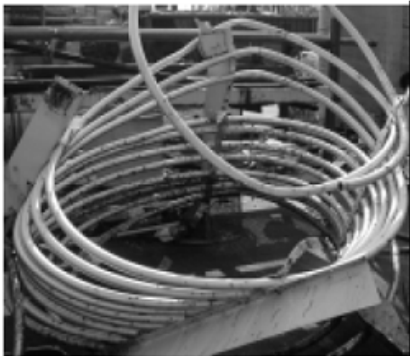
7. #2 ()

The internal steam coil from tank #2 (Figure 7) was found approximately 30 feet to the south of the tank's original location.

As the feed tank came apart, the coil was ejected and broke apart transversely. The coil retained its round configuration, indicating that the tank did not fail because of an internal deflagration or detonation, which would be expected to deform the coils—but because of pressure exerted somewhat evenly around the circumference of the vessel. CSB tested the coil to determine if a steam leak could have been a causal factor in the incident but was unable to determine whether the coil broke prior to, or as a result of, the explosion. No leaks were found in the intact portions of the coil.

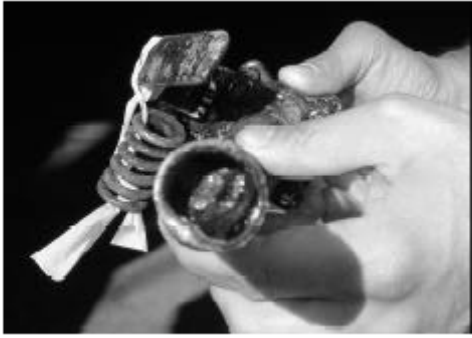
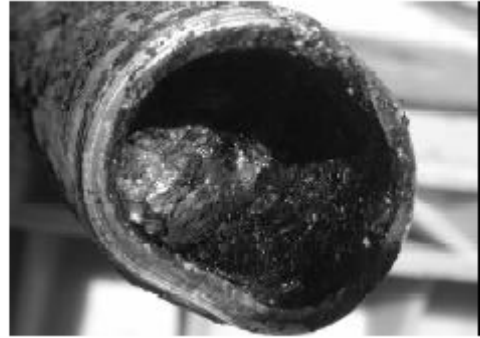
The 1-inch vent valve and a portion of the vent pipe were recovered in a parking lot, approximately 250 feet west of the tank's original location. The valve and pipe were plugged with a hard, sticky black material—typical of overcooked caramel color liquid (Figures 8 and 9). As observed by CSB, the valve appeared to be approximately one-quarter open; however, due to the effects of the explosion, CSB was unable to ascertain the valve position prior to the event.

Figure 8 Plugged 1 -inch vent pipe.
pluggage.

- A tank insulation-retaining band snapped, indicating that the tank shell most likely expanded in response to increased pressure.
- The 1-inch valve on the vent line was most likely closed as the caramel liquid heated. As the mixture overheated, expanding and emitting steam and vapor, material filled and plugged the vent line, blocking pressure relief. Evidence indicates that this quarter-turn ball valve and vent line—the only vent on the vessel—was plugged (Figures 8 and 9). The lead operator most likely opened the vent line valve but to no effect.

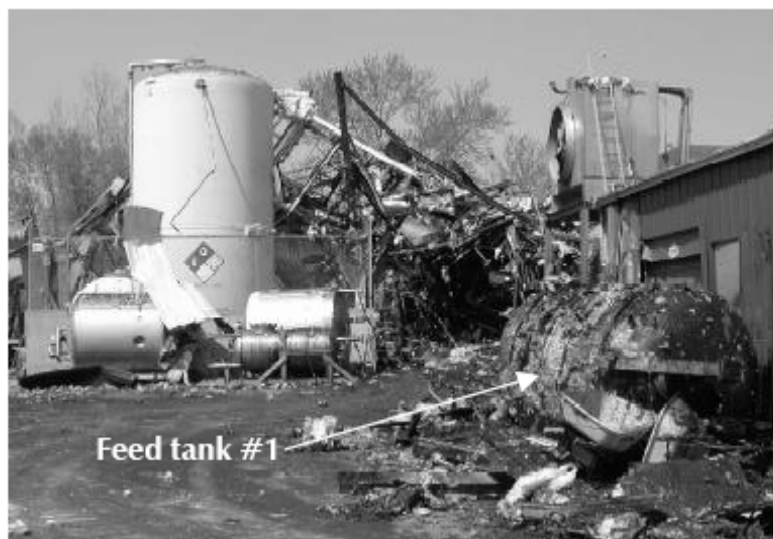
10. #1

Feed tank #1 was propelled to the south and landed on its side, approximately 150 feet from its original location (Figure 10).

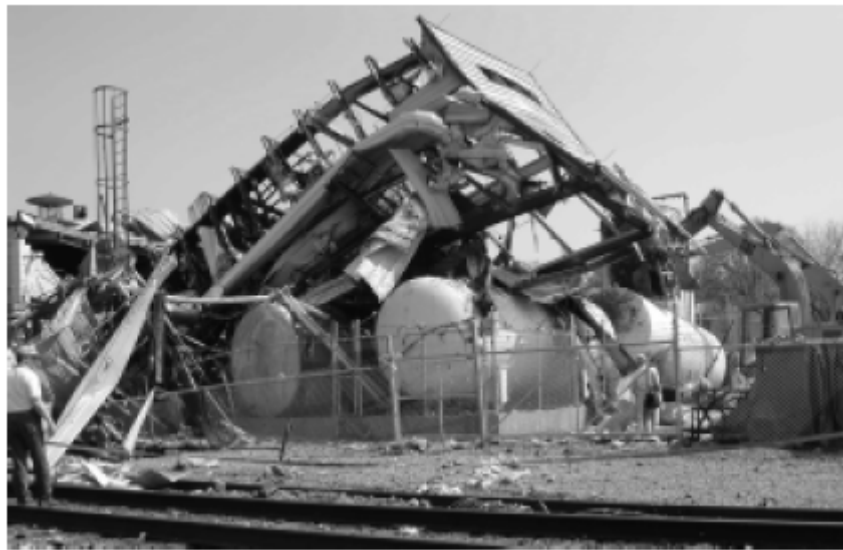
11.

- The spray dryer area at the west end of the DDW site was totally destroyed (Figure 11).
- A concrete block wall to the east of the spray dryer area collapsed.
- A 6-inch gas line ruptured; however, automatic valves prevented release of the natural gas.
