**KOREA OCCUPATIONAL SAFETY & HEALTH AGENCY**

## **INVESTIGATION REPORT**

### **Explosion in Compressor Operating Panel**

**Ulsan, Korea  
September , 2004**

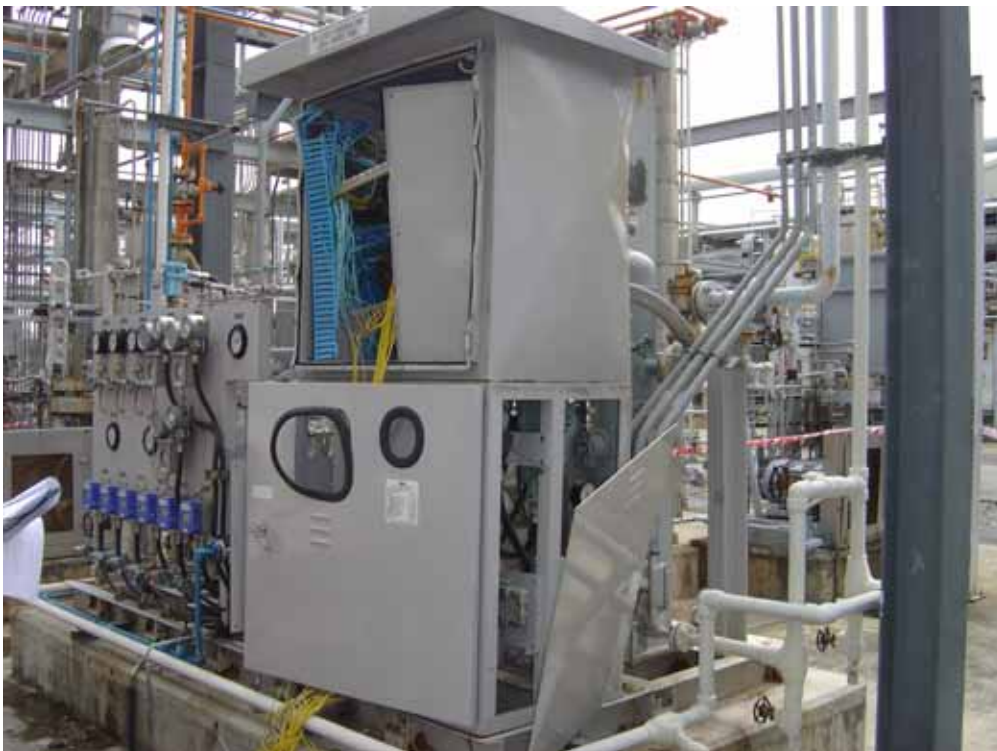
**Figure 1: Damaged compressor operating panel cover after explosion(weight about 60kg)**

In the morning of September, 2004 a explosion was occurred in a compressor operating panel in a P.P (Polypropylene) Plant, Ulsan, Korea. Two employees were killed on the spot, the panel was damaged itself. The explosion was arisen due to high pressure hydrogen trespass through nitrogen line for compressor panel purge. Nitrogen was supplied to purge compressor suction part during the maintenance period and also to pressurize and hold positive pressure compressor operating panel inside from the same header. And when nitrogen valve was opened to purge compressor suction part to replace the compressor inside valves, nitrogen valve connected to compressor operating panel was closed by mistake. So compressor operating panel inside finally remained in atmosphere and air entered in panel through openings.

After the replacement of compressor inside valves nitrogen purge line was not exactly blocked. Between compressor suction part and N2 header line two check valves and two gate valves and a globe valve and a spectacle blind was installed but two check valves passed, two gate valves(valve 1,2) opened, a globe valve passed, a spectacle blind unused. And high pressure hydrogen trespassed in the compressor operating panel through the nitrogen purge line according to compressor running and the explosion finally occurred in panel by electric sparks.

A spectacle blind should be located in back of a block valve so that N2 purge line should be blinded after the maintenance of compressor suction part, and purge gas to hold positive pressure in an electric panel is recommended to change instrument air instead of nitrogen gas.
